## THESIS

**DEVELOPMENT OF CARBON NANOTUBE-BASED SENSOR  
TO MONITOR CRACK GROWTH IN CRACKED ALUMINUM  
STRUCTURES UNDERNEATH COMPOSITE PATCHING**

June 2014

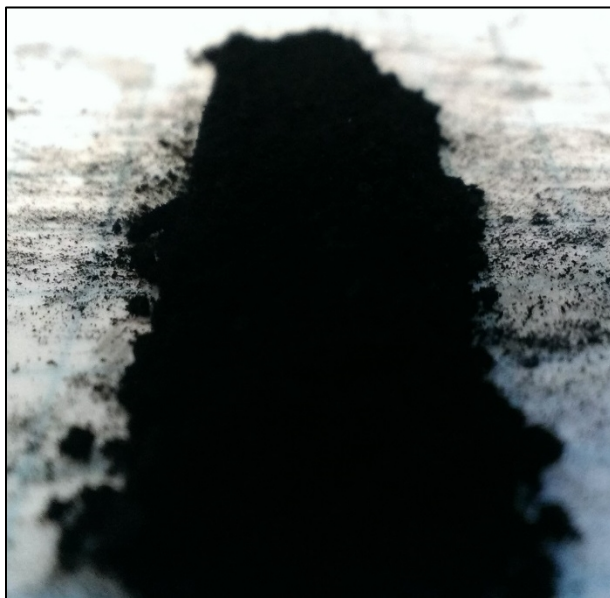
Figure 1. CNTs formed in a line two inches in length (top to bottom)

As described earlier, carbon nanotubes (CNTs) have electrical characteristics which allow them to conduct electricity. Though not as conductive as 28 gauge steel galvanized wire (utilized in this study), which has a resistance of approximately  $2\Omega$  for a two inch sample, using two inch lengths as a comparison, CNTs have approximately  $6k\Omega$ 's of resistance. It is important to understand that this is measuring the resistance of CNTs on a flat surface spread out over a 2 inch distance. An individual CNT has a much lower resistance. In normal form, CNTs looks like black dust as shown in Figure 1. The dust is actually clumps of CNTs as the eye cannot see nanoparticles without some type of magnification. The clumps are due to Vander-Wall forces which will not be discussed in this study [3].

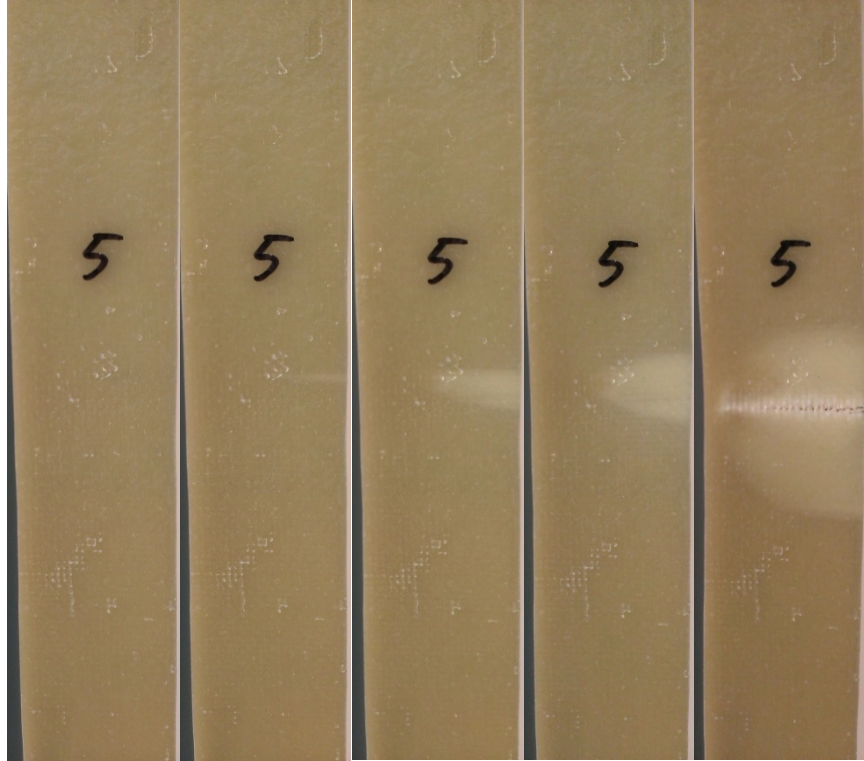
Figure 10. Delamination of sample 5 as loading is increased (left to right)

Figure 10 shows that the delamination in the center of sample 5 growing as the loading is increased to a maximum load of 14633.28N. The delamination is shown as the white areas as it is between the individual layers of the composite as shown in Figures 11 and 12.

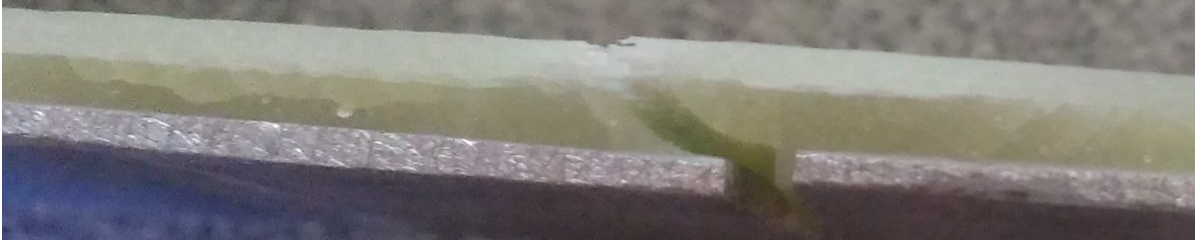
Figure 12. Side view of sample 5 showing delamination in composite

Figure 11 shows delamination between the composite and the base layer of resin along with the cracked base layer near the crack in the aluminum. But, delamination between the base layer and the aluminum has not occurred. Figure 12 shows the delamination within the composite from the side as the layers are white and slightly spread out.

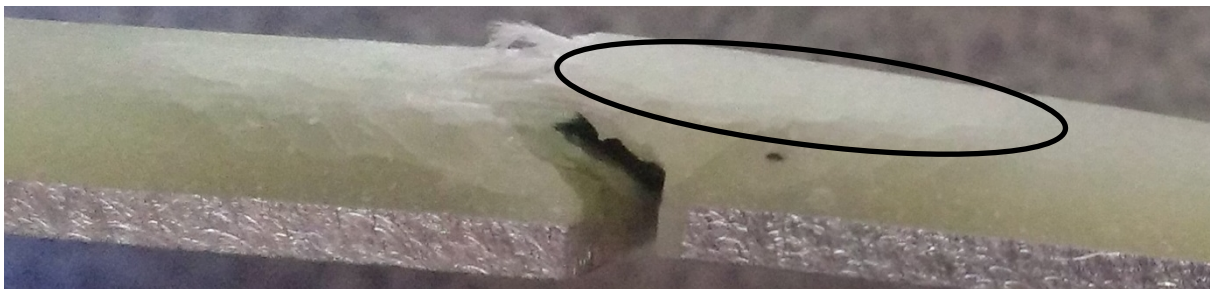
Figure 16. Side view of CNT sample 5 showing small delamination in composite

Figure 15 shows the delamination growth in sample 5 as the loading was increased to a max load of approximately 13,838N. Similar to Figure 10, delamination is shown as the white area within the sample. This delamination is within the composite itself as shown in Figure 16.

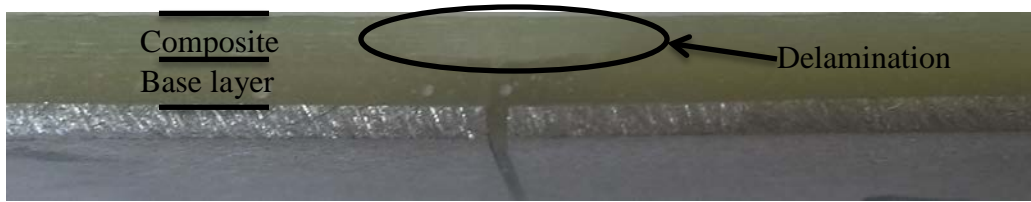
Figure 22. Sample 4 showing delamination within the composite only

Figures 22 and 23 are side views of sample 4 showing that the delamination is only in the composite. There is no delamination between the aluminum and the base layer of resin or between the base layer and the composite. Figure 23 shows an intact bond between the aluminum and the base layer and it is visible that there is no cracking of the base layer as compared to and shown in the tension samples.

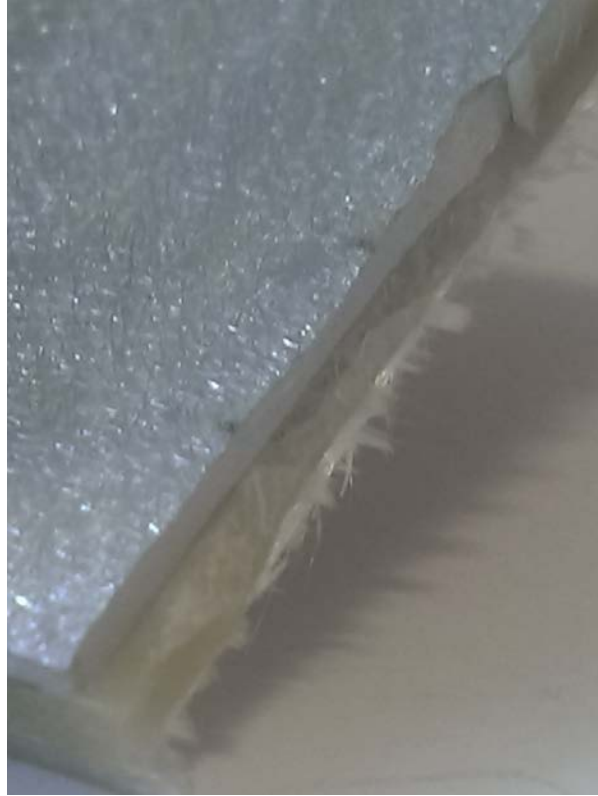
Figure 25. Cracked edge of sample 2 showing brittle fracture surface

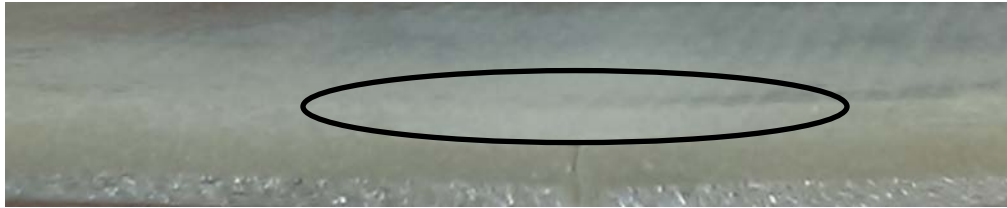
Figure 27. Sample 2 showing delamination within the composite only

Figure 27 shows the delamination only occurring in the composite which is the same seen in the composite samples. Figure 28 shows no delamination occurring

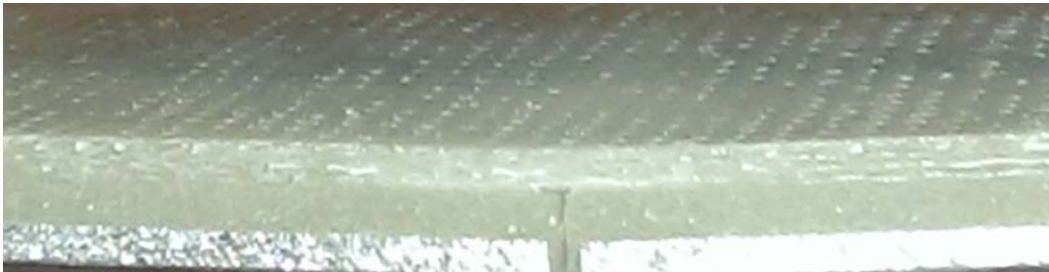
Figure 28. Sample 2 showing no delamination between layers or aluminum

between the aluminum and the base resin layer or the base resin layer and the composite. This is also consistent with the composite samples which reduce probability of errors in sample preparation.

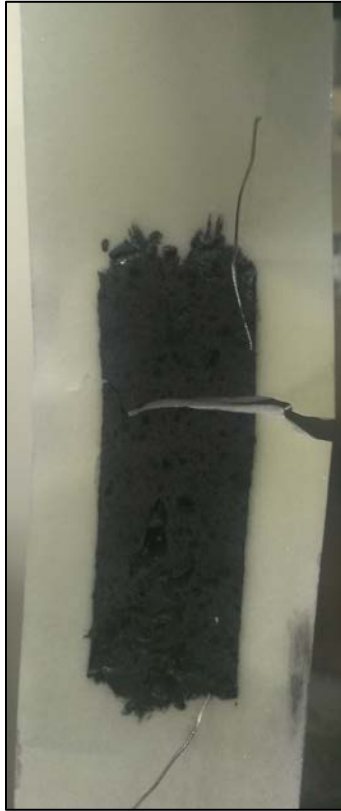
Figure 35. CNT sensor utilization and proof of usability

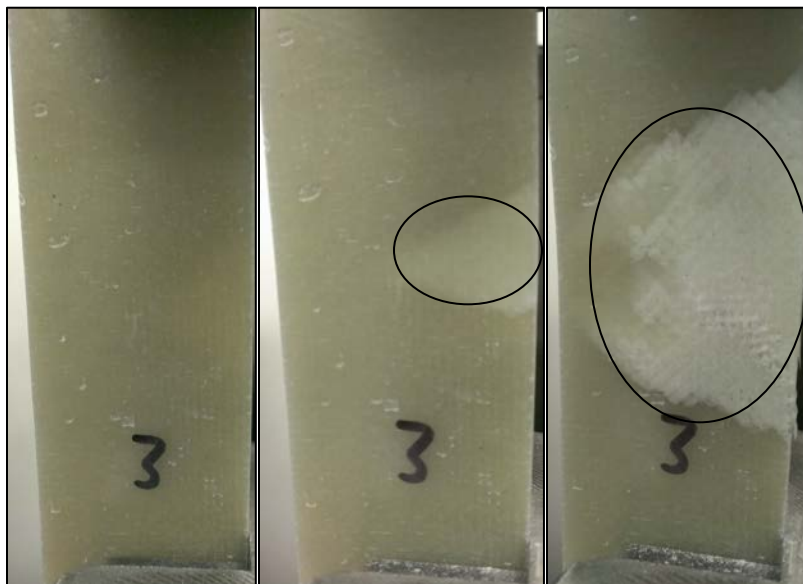
Figure 38. Full length composite sample, initially unloaded (left), initial delamination (middle), final delamination (right)
